WEEKLY CONSTRUCTION PROGRESS AND INSPECTION REPORT

Period Ending November 22 nd , 2016 Weekly # 3
Project AIP Number 03-49-0037-033-2016

Airport Name Vernal Regional Airport (VEL)	
Project Description Runway Reconstruction	Contractor's Name W.W. Clyde & Co.
1. Rough Estimate of Percent Completion to Date of Construction Phases <i>(Include items such as clearing, grading, drainage, base, surface, lighting, etc.)</i> "Notice to Proceed" issued November 7, 2016 Bid Schedule 1 Percent Complete: 5% Bid Schedule 2 Percent Complete: 14% Bid Schedule 3 Percent Complete: 3% See attached Percent Complete spreadsheet.

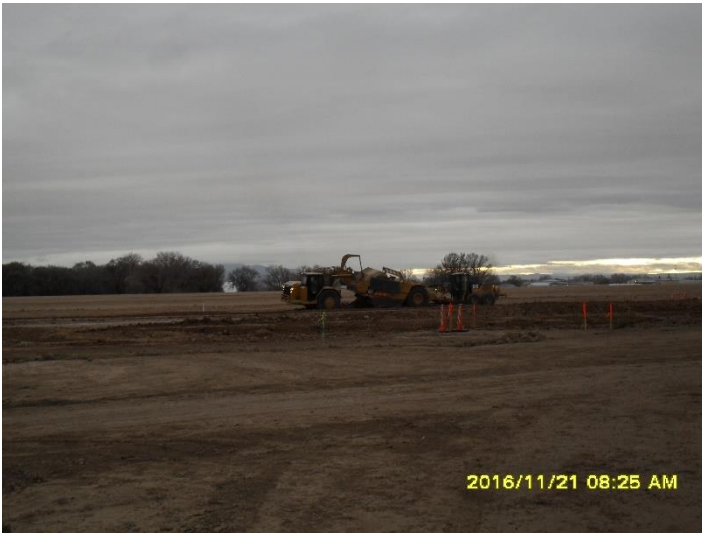
P-152 excavation to embankment and compaction (11/21)

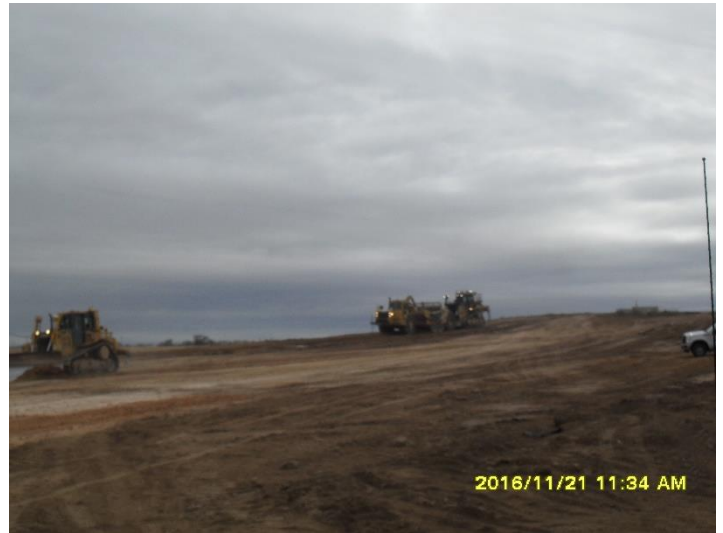
P-152 excavation to embankment and compaction (11/21)

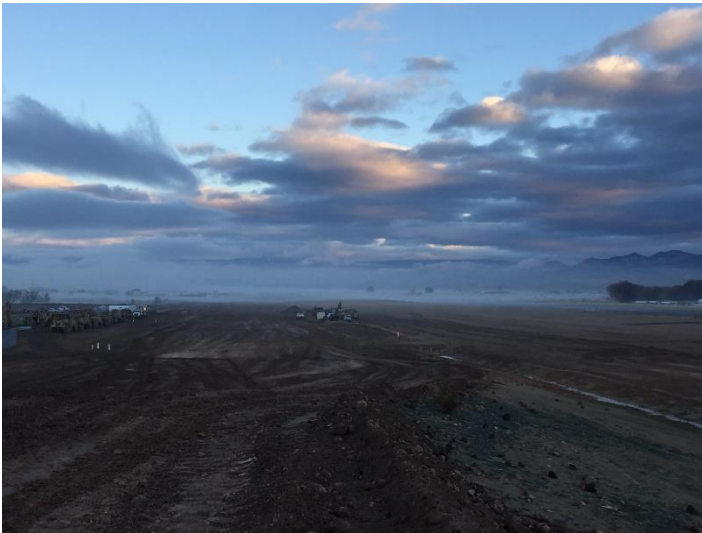
Weather day-no work completed (11/22)

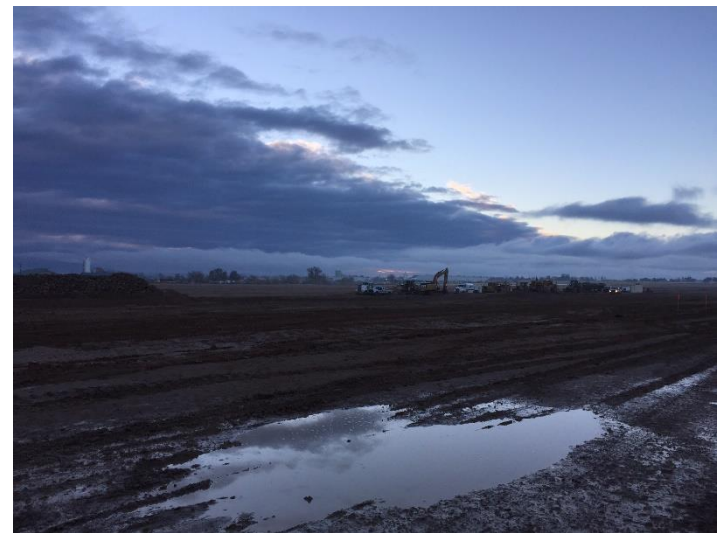
Weather day-no work completed (11/22)
